ESPACE

JE0 G

Cancels and replaces Technical Note No. 3268A of August 1999.

17B ENGINE FAULT

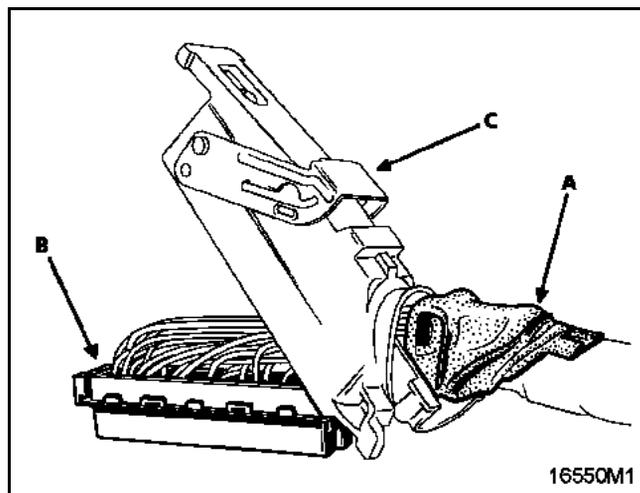
Fig. 1

– Ingress of water between the wiring harness and the injection computer connector causing oxidation of the connections.

- Check for oxidation inside the injection computer connector.
 - Remove the clamps.
 - Release the cap (A) (Fig. 1).
 - Remove the screws and withdraw the connector (B) (Fig. 1) while pulling back the connector cover (C) (Fig. 1).
 - Look for signs of oxidation.
- If the connections are oxidised:
 - Apply the technical note.

- Replace engine wiring and injection computer.

- Replace the engine wiring and the injection computer if the connections are oxidised:
 - Disconnect the battery.
 - Remove the injection computer.
 - Disconnect the sensors.
 - Remove the automatic gearbox computer.
 - Disconnect the connections in the engine connection unit.
 - Suspend the engine on the timing side.
 - Remove the engine wiring.
 - Fit the new engine wiring.
 - Refit and connect all parts that have been removed.
