## REPLACING THE COMPLETE HEADLINING

**ROOF MEDALLIONS**

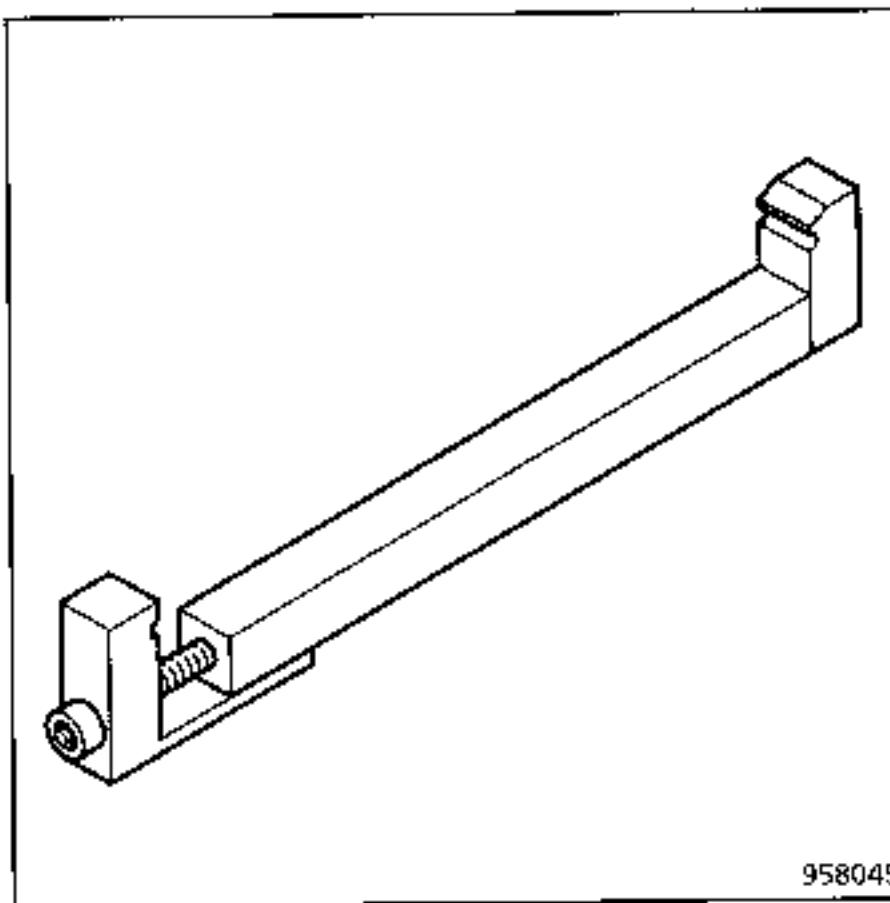
958045

**Car. 1253** tool for removing and refitting the adjusting base strut (front seat base).

Compress the assembly using tool Car.1253

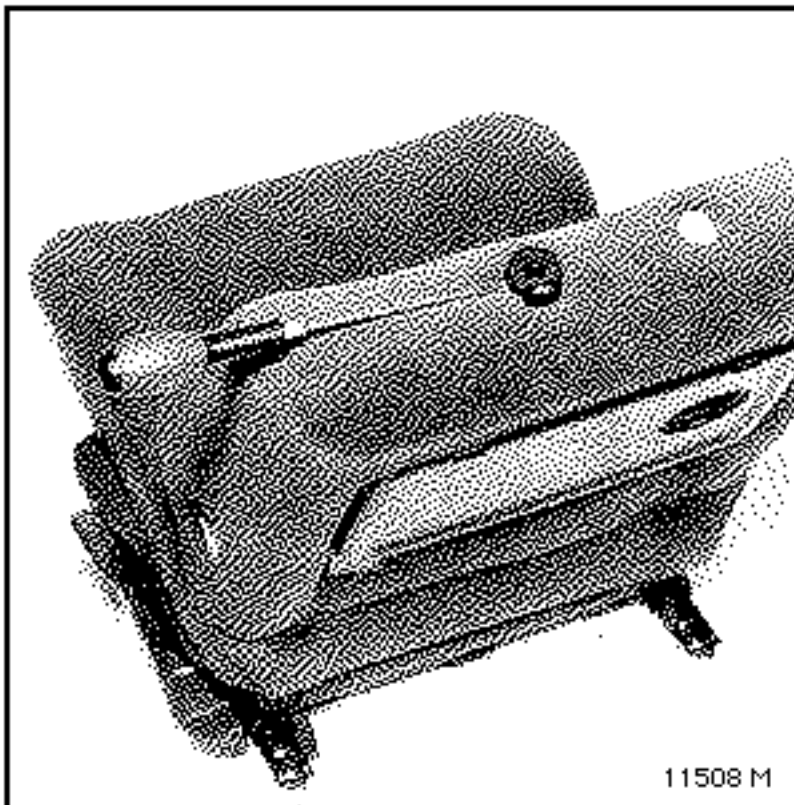
- the seat mountings (see section 75A),
- the head restraint and the upper sections of the head restraint guide, using a screwdriver,

- the side housings,
- the seat cover and its foam,
- the two rubber fastenings,
- the bar,

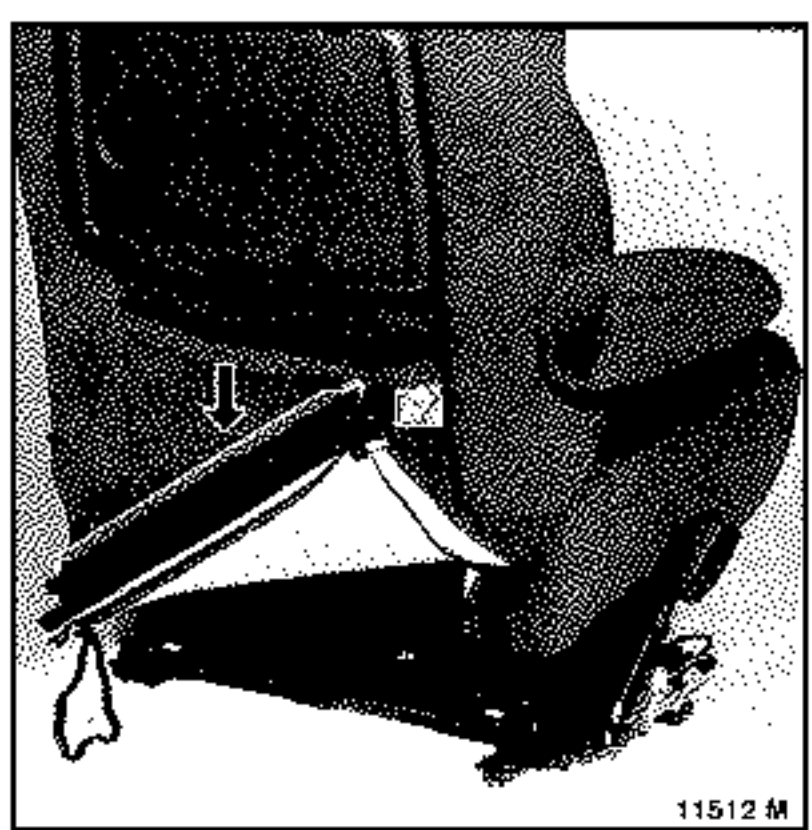
Remove the 4 lower clips mounting the seat cover on the seatback (depending on version).

Release the 2 rubber mountings which are secured at the front by clips (depending on version).

At the rear, remove the 2 metal sections.
