Espace

87 PASSENGER COMPARTMENT CONNECTION UNIT (BII)

TECHNICAL DEVELOPMENT OF VEHICLE JE0X

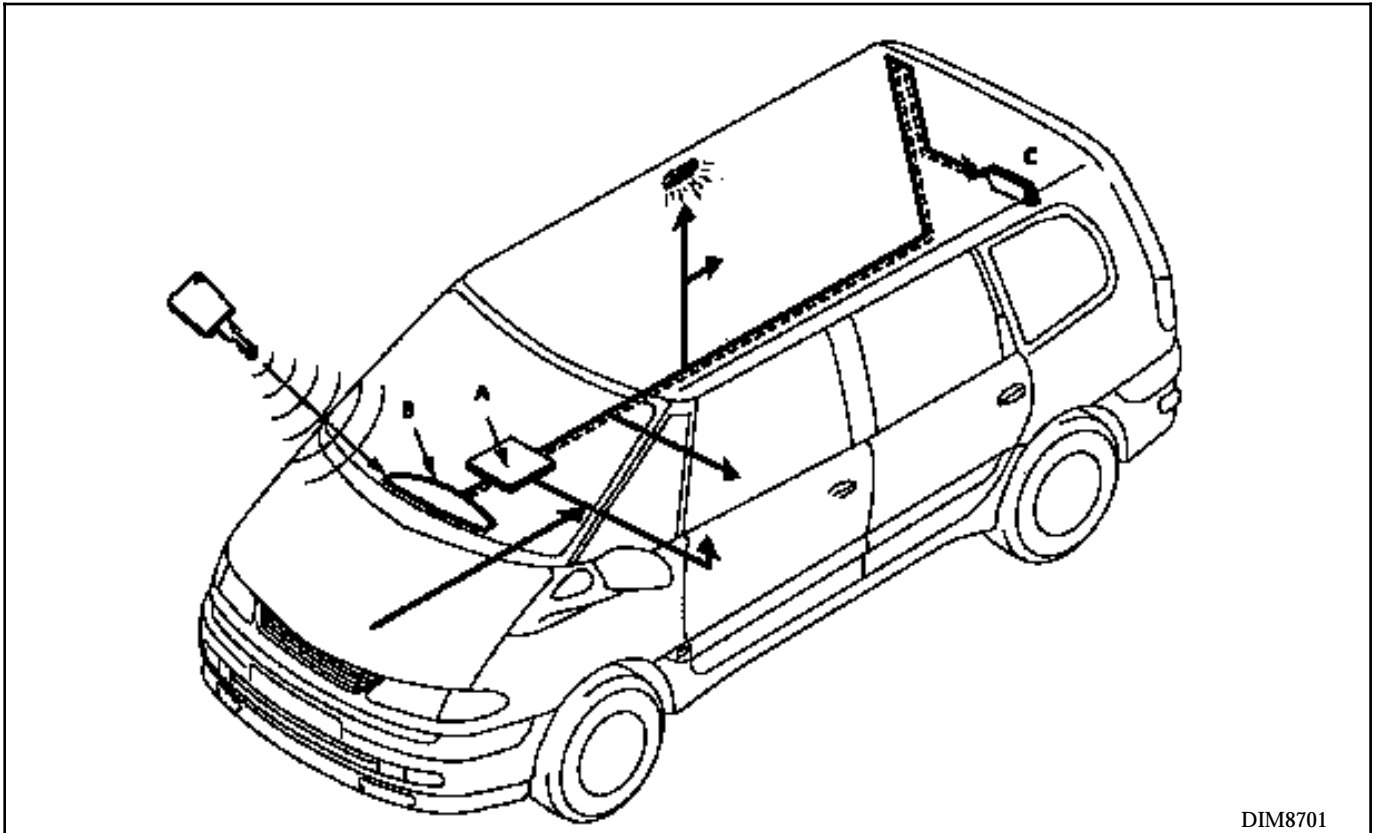
DIM8701

LOCATION OF COMPONENTS RELATED TO THE PASSENGER COMPARTMENT CONNECTION UNIT BII

----- multiplexed connection

A : Passenger compartment connection unit (BII)

B : Instrument panel

C : Tailgate module

- receives driver's commands and engine alerts,
- sends digital codes to the instrument panel and the tailgate module, via two wires for the instrument panel and one wire for the tailgate module which carries several commands simultaneously.

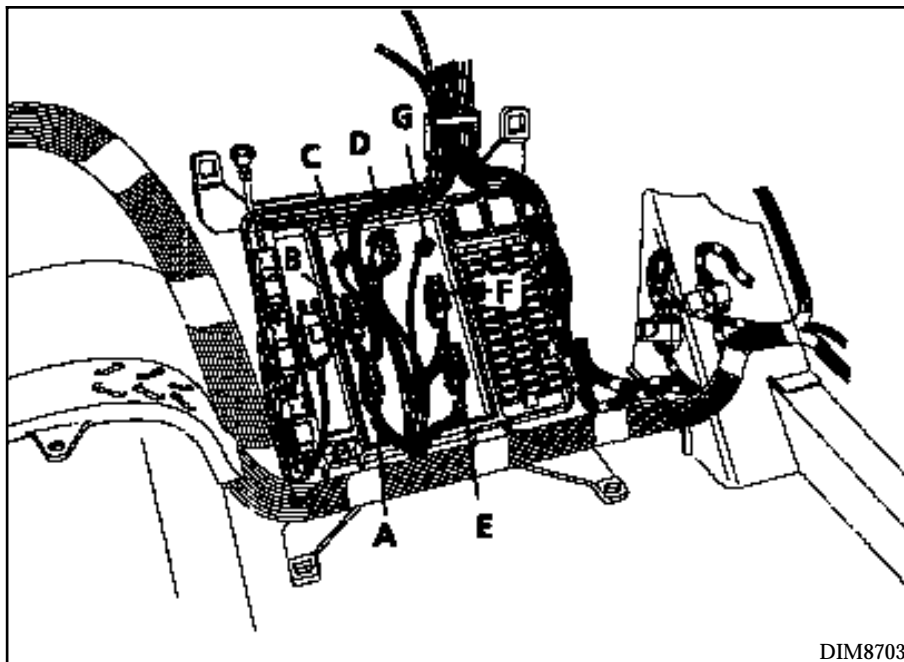
Heated rear screen relay on the left hand side.

After ignition feed relay on the right hand side.

- A 26 track yellow connector
- B 26 track yellow connector
- C 1 track white connector
- D 16 track black connector

- E 12 track blue connector
- F 26 track blue connector
- G 1 track grey connector
